REF: TREES AT LLYS ANWYL, CHURTON ROAD, RHYL

PROJECT
Llys Anwyl
Churton Road
Rhyl

TITLE
Tree Constraints Plan (TCP)

Drawing Number	TCP-01	A2
REV.

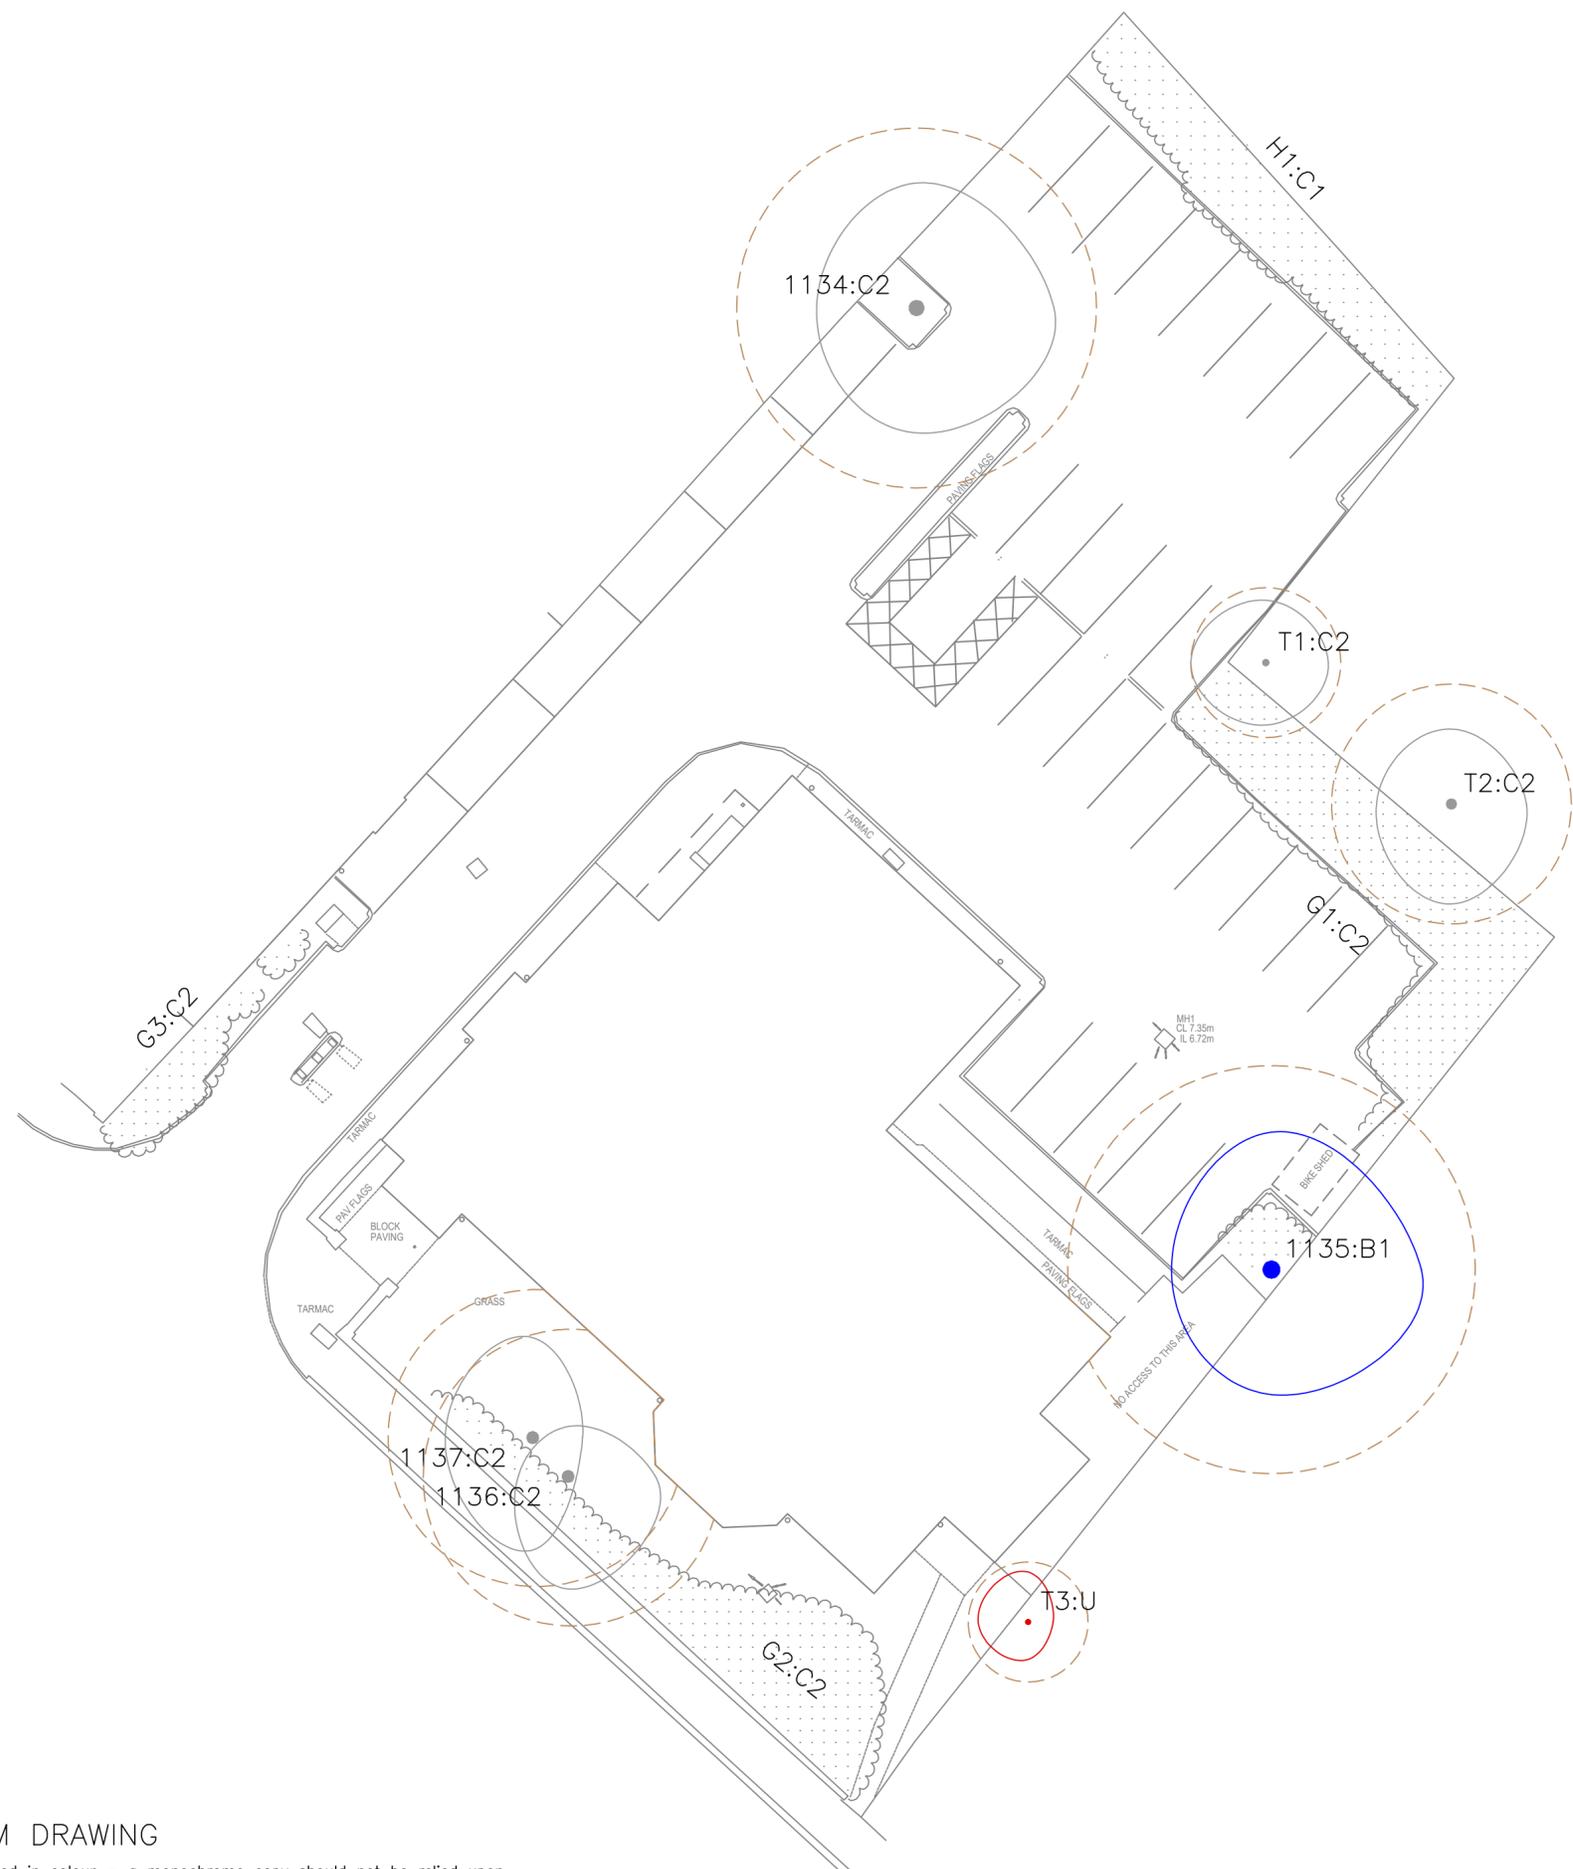
Tree Ref	Species	Ht (m)	DBH (mm)	RPA (m ²)	Crown Spread				Age Class	Crown Clearance (m)	Observations	Management	BS Cat	
					RPA RAD (M)	N	S	E						W
1134	Sycamore; <i>Acer pseudoplatanus</i> <i>Aceraceae</i>	12	600	162.9	7.2	5#	5	5.5	4#	M	1.5	Major dieback and deadwood in upper crown, historical pruning wounds throughout with only partial occlusion, epicormic growth at base	Remove deadwood and monitor condition. If condition worsens, consider removal and replacement	C 2
H1	Privet; <i>Ligustrum spp.</i> <i>Oleaceae</i>	2	n/a	n/a	n/a	n/a	n/a	n/a	n/a	M	0	Managed hedge. No significant defects	No work required	C 1
G1	Mixed species group inc. sycamore natural regeneration	2 to 3	n/a	n/a	n/a	n/a	n/a	n/a	n/a	Y-MA	0	Dense unmanaged group with dense covering of bramble in places	No work required	C 2
1135	Sycamore; <i>Acer pseudoplatanus</i> <i>Aceraceae</i>	11	680	209.2	8.2	5.5	5#	6	4	M	2.5	Heavily ivy clad which impeded survey, dieback and deadwood in upper crown, minor leaf scorch, historical pruning wounds showing some signs of occlusion	Remove deadwood and monitor	B 1

T1	Sycamore; <i>Acer pseudoplatanus</i> <i>Aceraceae</i>	8.5	250	28.3	3.0	2.5	2.5#	2.5	3#	MA	2	Third Party Tree. Wall impeded survey. Natural regeneration, minor deadwood	No work required	C 2
T2	Hawthorn; <i>Crataegus monogyna</i> <i>Rosaceae</i>	7	400	72.4	4.8	3#	4#	3#	3#	M	2.5	Third Party Tree. Wall impeded survey. Minor deadwood, minor dieback in upper crown	No work required	C 2
T3	Sycamore; <i>Acer pseudoplatanus</i> <i>Aceraceae</i>	6.5	200	18.1	2.4	2	1.5#	1#	2	MA	1	Third Party Tree. Growing in tight gap between wall and neighbouring garage; forcing wall over	Remove. Third Party tree; however, it is damaging boundary wall and is of very low quality	U
G2	Mixed species group inc. sycamore natural regeneration	2	n/a	n/a	n/a	n/a	n/a	n/a	n/a	M	0	Formally planted border. No significant defects	No work required	C 2
1136	Sycamore; <i>Acer pseudoplatanus</i> <i>Aceraceae</i>	9.5	470	99.9	5.6	2	4.5	3.5	2	M	1.5	Heavily ivy clad which impeded survey, bifurcates at 2 metres in height- top of Northerly stem closest to building dead from 5 metres in height, unbalanced with Southerly crown bias due to close proximity to building and to neighbouring tree, epicormic growth at base, minor deadwood	Outgrown its context (too close to building); consider removal and replacement with more suitable species	C 2

1137	Sycamore; <i>Acer pseudoplatanus</i> <i>Aceraceae</i>	9.5	470	99.9	5.6	4	4.5	2	3.5	M	2	Heavily ivy clad which impeded survey, bifurcates at 2 metres in height- Eastern stem appears to have been topped at 3 metres in height but heavy ivy cover impeded inspection, major deadwood, decay in primary limb in upper crown- extent of decay unknown, unbalanced with southerly crown bias due to close proximity to building and to neighbouring tree	Outgrown its context (too close to building); consider removal and replacement with more suitable species. Remove deadwood	C 2

Tree Ref	Species	Ht (m)	DBH (mm)	RPA		Crown Spread				Age Class	Crown Clearance (m)	Observations	Management	BS Cat
				RPA (m ²)	RPA RAD (M)	N	S	E	W					
G3	Mixed species group inc. sycamore natural regeneration	1 to 2.5	n/a	n/a	n/a	n/a	n/a	n/a	n/a	MA	0	Mix of formal planting and sycamore natural regeneration	No work required	C 2
