## LLYS ANWYL

# PRELIMINARY BAT ROOST ASSESSMENT, PRELIMINARY ECOLOGICAL APPRAISAL AND BAT EMERGENCE SURVEY

Report Ref EE.705.20.PK

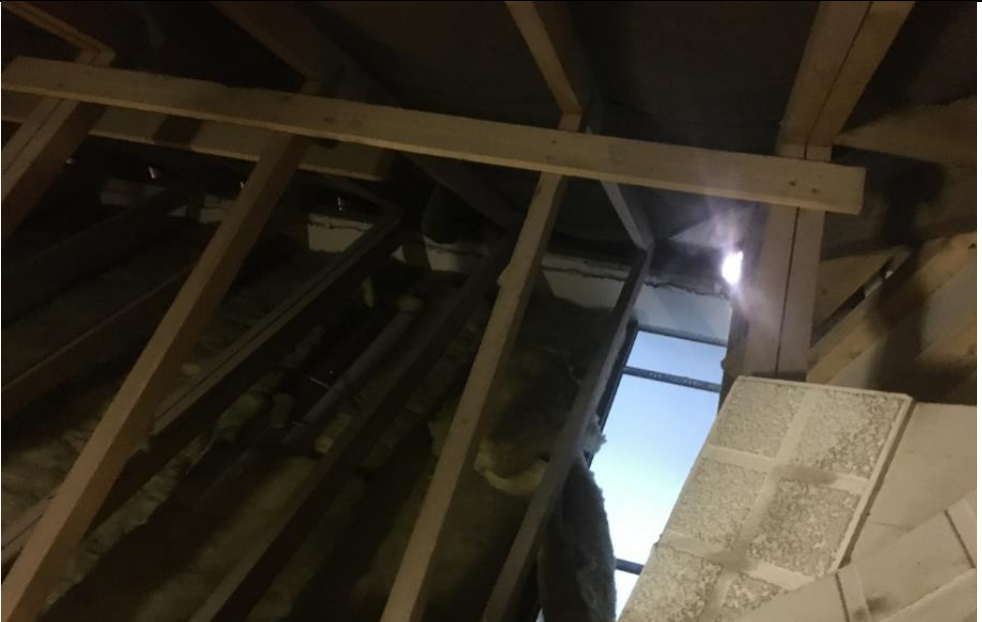
Building Feature	Description	Photos
Two Storey Extension at the rear	The internal roof inspection showed the roof void of the extension was felt lines with two open vents in the ceiling. There are several gaps where light enters the roof space at the eaves. The height of the space is approx. 3.5m, length 14m and width 14m. No droppings or evidence of bats within the loft space was found.

A photograph showing the internal structure of a roof void. The image captures a network of wooden rafters and beams. A window is visible on the right side, allowing natural light to enter the space. The overall appearance is that of a well-ventilated but empty loft area.

- 5.1.1 An internal inspection of the building showed that there were light gaps showing from around the eaves in the two storey extension as well as two open vents in the roof. The main building roof appeared to be sealed from within. The windows appeared tightly sealed.
- 5.1.2 The external assessment of the building identified several missing tiles with missing mortar which provided small gaps that could be utilised by bats. Therefore the building was assessed as having **low** bat roost potential.
- 5.1.3 The small bike shed was considered to have **negligable** roosting potential as it was open sided and light throughout the day with no crevices considered to be suitable for bats.

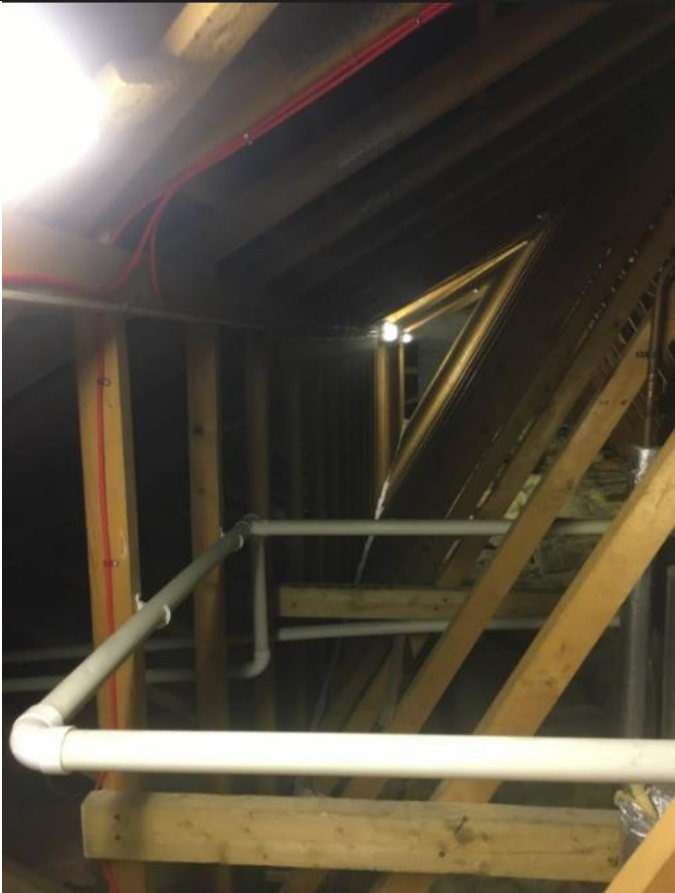
Roof Void in Main Building

The roof void in the main building appears well sealed with felted underside of the roof and no visible gaps. The roof height was approximately 3m at the apex, length 20m and the width 11m. No droppings or evidence of bats within the loft space was found.

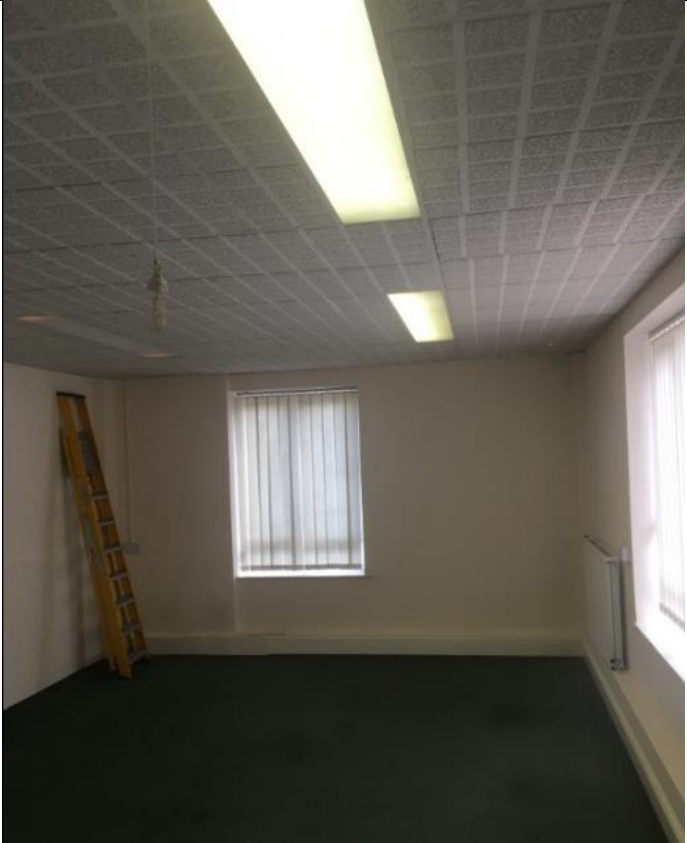
Internal rooms

The rooms were used for office space with suspended ceilings. They were well lit with multiple well sealed windows in the walls. No visible gaps in the walls or in to the loft spaces above.

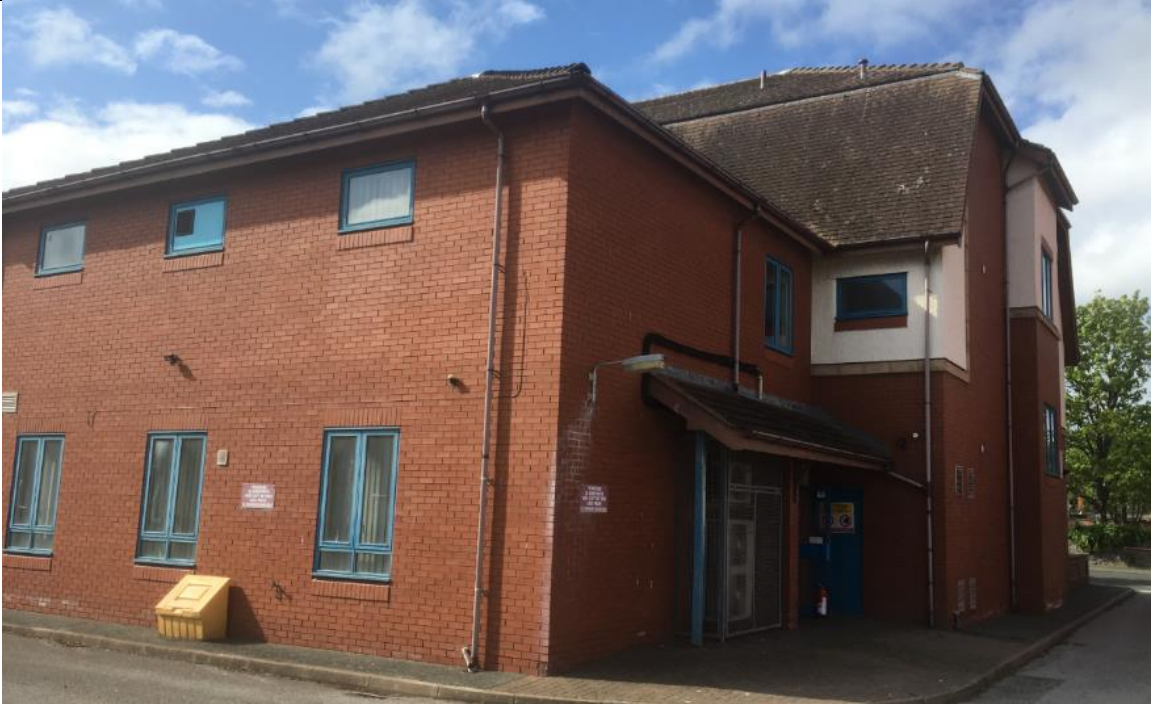
Building Feature	Description	Photos
<b>Roof of the extension</b>	The roof is pitched with concrete tiles. The roof appears to be in good condition with tight flashing between the extension and the main part of the building. The gaps observed in the eaves are not obvious from the outside.

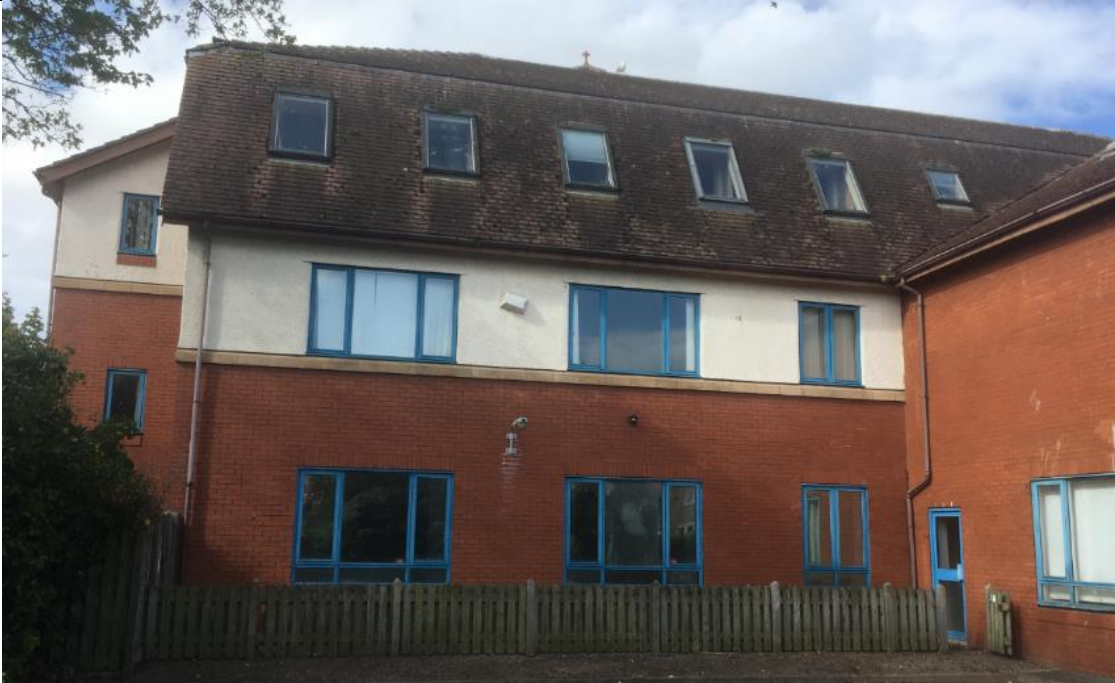
**Roof of the main building**

The roof of the main building is pitched with concrete tiles. There are some missing ridge tiles on the north eastern and south eastern hips. There is missing mortar beneath these tiles and further evidence of slipped tiles further up the roof.

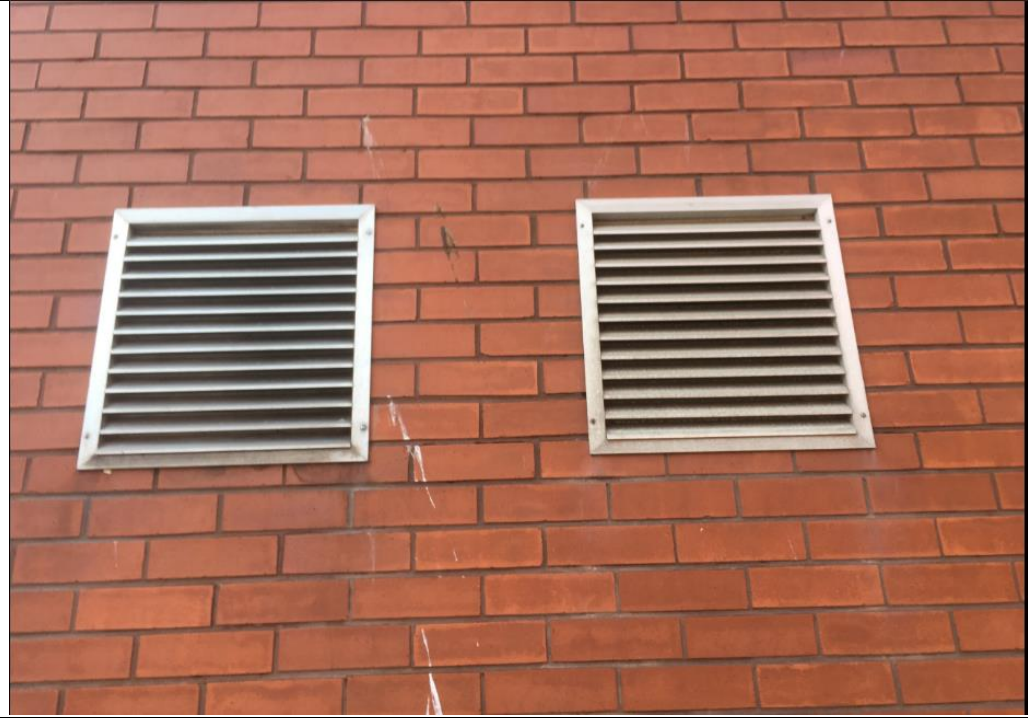
<p><b>Walls of the main building</b></p>	<p>There are several vents on the walls of the main building which provide ventilation within. It is not clear whether or not the vents have an internal mesh covering.</p>

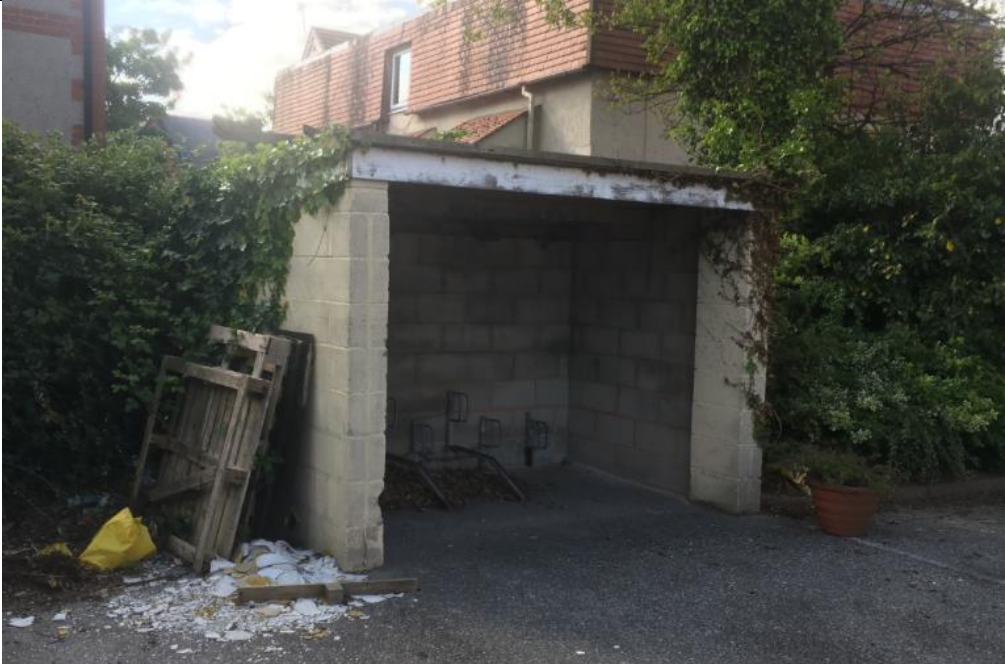
<p><b>Bike shed</b></p>	<p>The small open sided bike shed is to the rear of the main building adjacent to the hedge on the southern boundary. The structure is breeze block built and has ivy growing on the external faces.</p>

- 6.2 An internal inspection was undertaken and a nocturnal emergence survey carried out. No bats were observed using the building as a roost and no evidence of bats within the loft space was found. It is therefore considered unlikely that there are any bats present within the building. However as bats are a mobile species, there is a possibility that they could move into the building therefore Reasonable Avoidance Measures are detailed below. The removal of the bike shed is not considered to be ecologically significant.

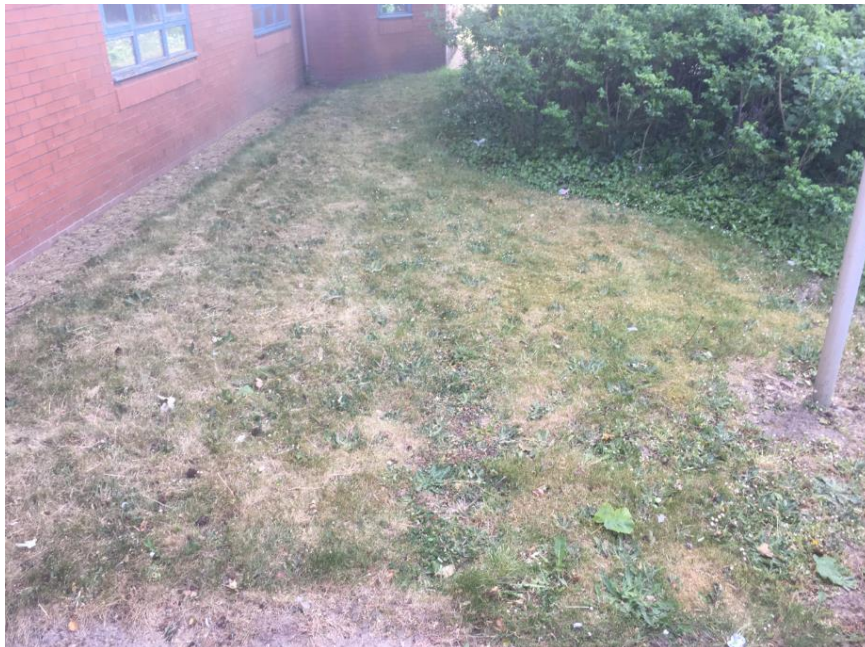
**PHOTO 4.1 IMPROVED GRASSLAND IN THE WEST OF THE SITE**

- 4.4.1 The main building onsite is a three-storey red brick structure with tiled roof. There is a two storey extension to the rear of the property. The windows are double glazed with wooden frames.
- 4.4.2 In the west of the site, in front of the main building, there is a small area of improved grassland (lawn). The lawn is bordered to the west by an ornamental hedge with a tree (*Acer sp.*) and to the east by the building. At the time of survey, the lawn appeared to be managed by regular mowing. Species present included buttercup (*Ranunculus sp.*), daisy (*Bellis perennis*), suspected perennial rye grass (*Lolium perrene*) and ivy (*Hedera sp.*). Photo 4.1.

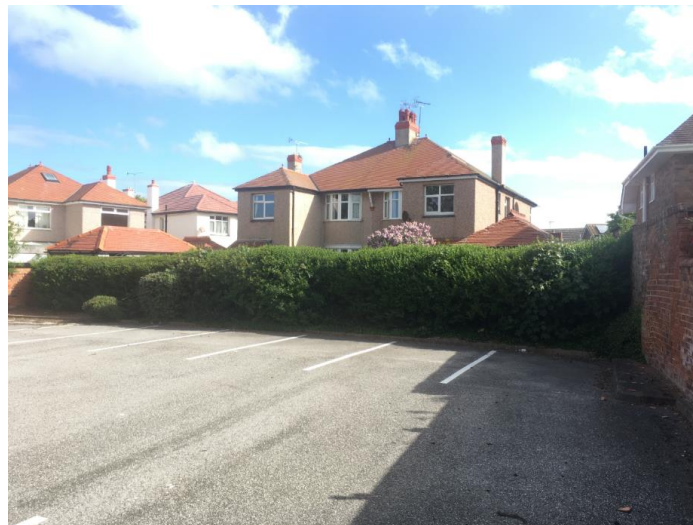
**PHOTO 4.2 HARD STANDING TO THE REAR OF THE MAIN BUILDING**

- 4.4.3 To the east of the main building there is a large area of hard standing, currently used as car parking and is not considered to have any ecological value. (Photo. 4.2).

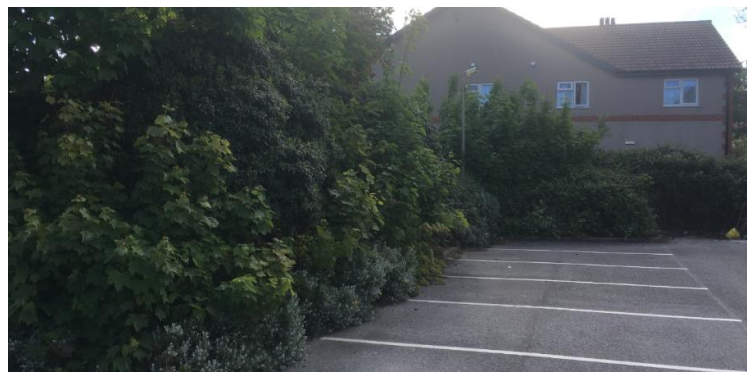
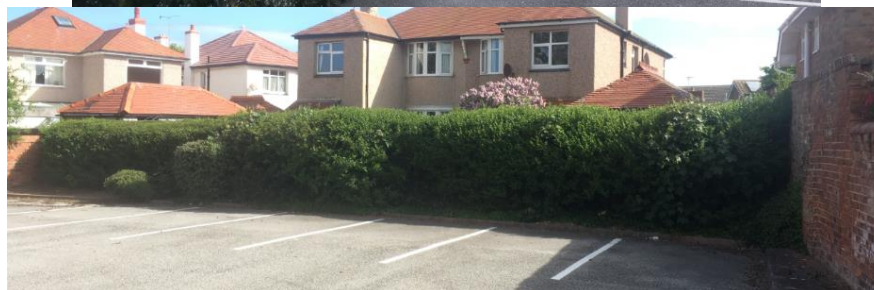
4.4.4 There are two intact hedgerows which make up the eastern boundary of the site (Photo 4.3 and 4.4). This hedge is dominated by laurel (*Laurus sp.*) and sycamore (*Acer pseudoplatanus*). On the southern boundary, there is a wall where the same hedgerow continues, and there is a large sycamore tree within it. The hedgerows are not connected to other linear features outside the site but provide good habitat for birds within the site.

**PHOTO 4.3 AND 4.4 EASTERN BOUNDARY HEDGES**

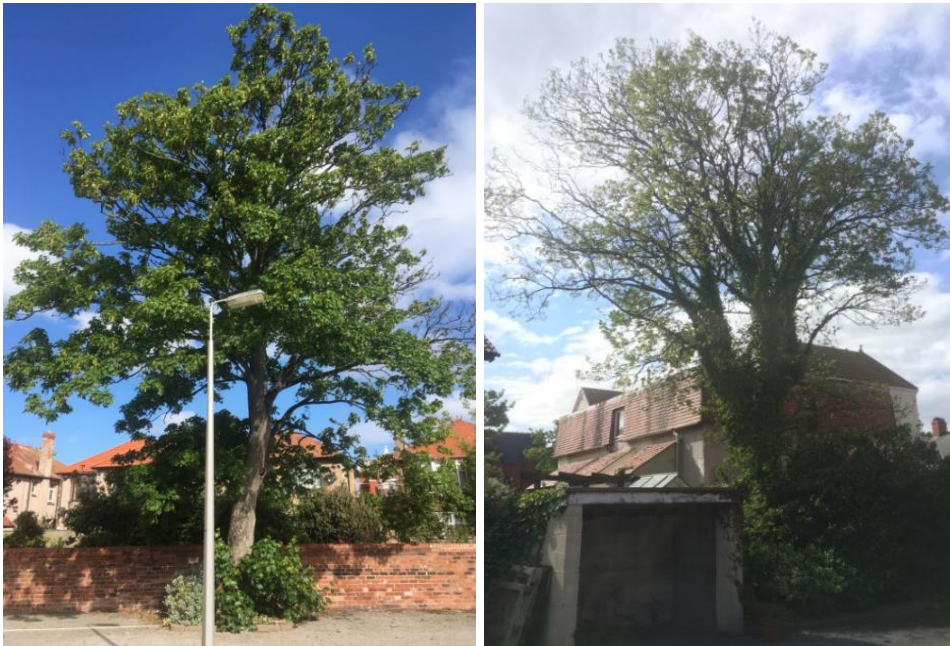
(Photo 4.6). The trees were assessed for roosting bat potential. No roosting features were identified from the ground although there is some ivy growth on the mature tree in the west of the site and in the south. It is considered however that the ivy is too dense for bats to access any features which may lie behind it.

**PHOTO 4.5 AND 4.6 MATURE TREES**
